# **AN ANALYSIS OF DOWNTOWN STOREFRONT IMPROVEMENTS**

## **A Selection of Wisconsin Case Studies**

**Bill Ryan, Amy Greil, Dayna Sarver, Joe Lawniczak, and Errin Welty**

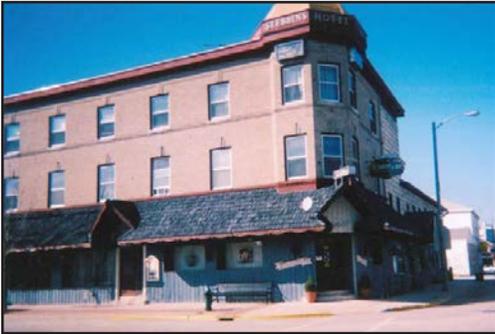
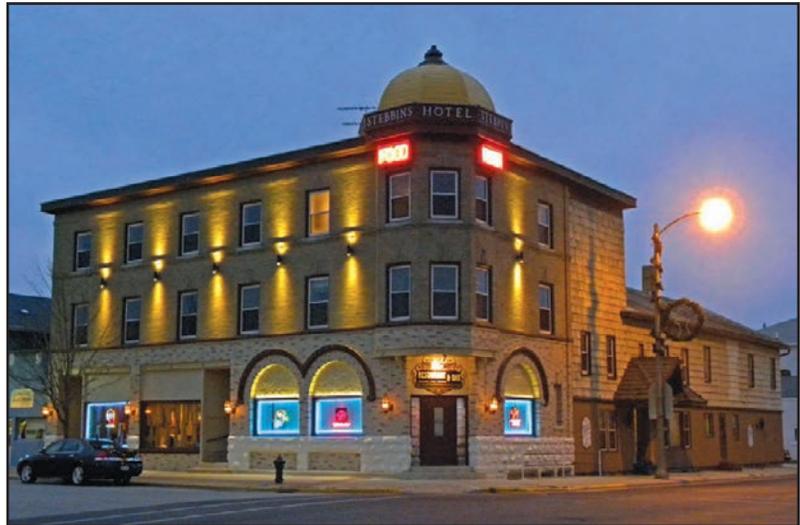
# Hotel Stebbins

Removing a 1960s façade revealed the hidden beauty of the early 1900s building. This generated interest in revitalization and in cultivating a sense of place.

A façade project in the 1960s concealed most of the stone and brick work around the base of the building. Once removed, masonry repairs were made. To preserve the stones and brick, the owner stained, painted, and added curbing around the base of the building to seal out moisture. Exposed steel beams used in the early 1900s architecture also needed repairs and unique steel scroll work was sandblasted and repainted. The exterior doors were removed in the entry way so an awning could be installed. New signage was added.

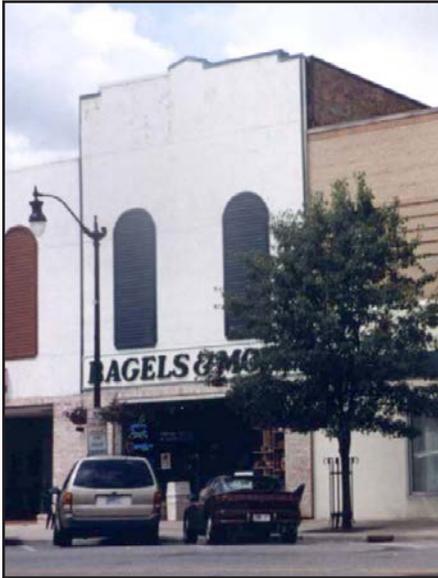
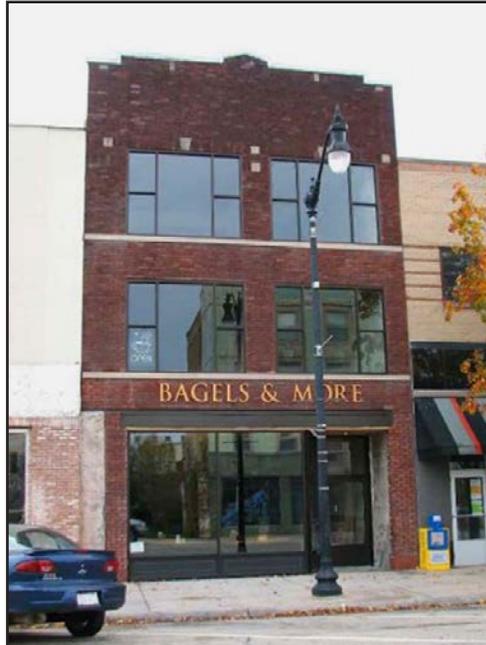
Improvements led to increases in first-time customers and sales.

Once the stucco façade was removed from the bagel shop, the building was cleaned and tuck-pointed. New windows replaced the cinder blocked spaces on the second and third story, transforming the façade. The owner changed the look of the sign, replacing plastic letters with more attractive and durable metal ones.

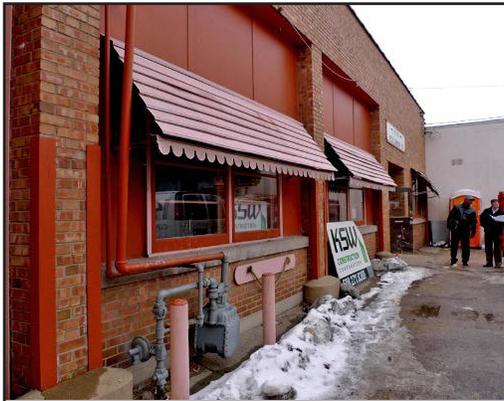
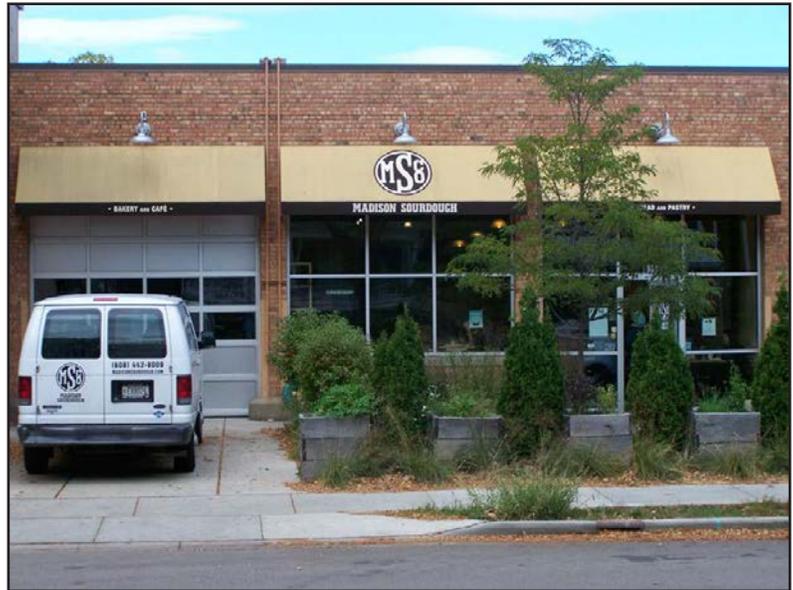
Improvements resulted in higher rents.

Leaky roof was repaired and masonry was tuck-pointed. Windows and doors, including the overhead door where the bread trucks load, were replaced. New awnings and exterior lighting were also installed.

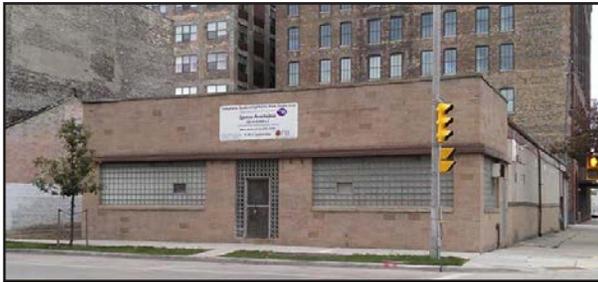
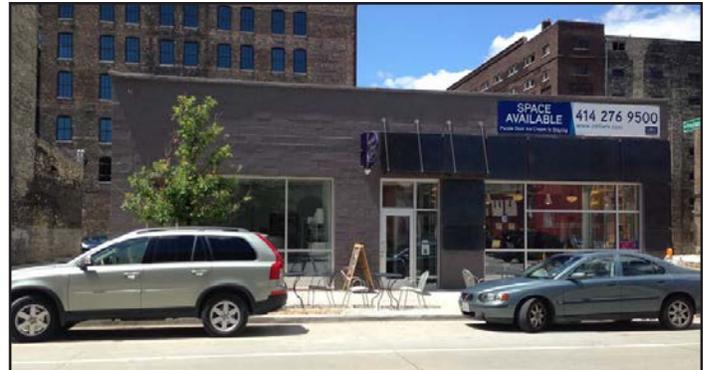
A manufacturing building converted to an ice cream shop serves the neighborhood, increases foot traffic, and has an economic multiplier effect in the area.

Storefront window openings were enlarged to allow natural lighting and connect interior and exterior seating areas. The door opening was altered and the interior atrium was enclosed with glass. Masonry was repaired and the surface painted. During nighttime hours, LED lights shine through the artistic sculptural panels over the doorway and windows. A new awning was also installed over the doorway.

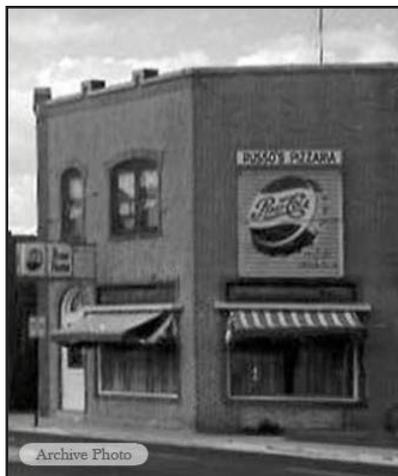
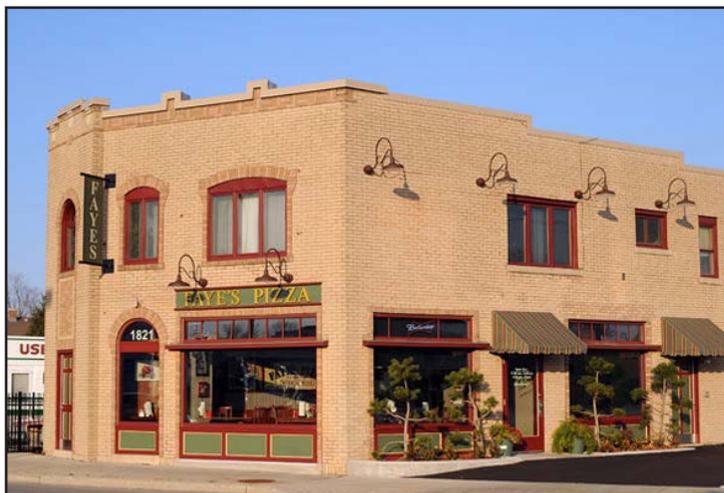
Opening the space up to natural light during the day and installing exterior lighting for the evening created a welcoming, safe environment for customers. The results were doubled sales volume and an expanded product line.

Built in the early 1900s, the building exchanged hands only a few times. In 1986, a car accident badly damaged the front dining room window. The owners at the time decided to cover over the damaged façade by enclosing all the lower level windows with brick. In 1996, Alicia Reichgeld Evans purchased the building and the business. Frustrated that the building was indistinct, Evans was motivated to make some upgrades to this "brick box" building.

All the previously obscured windows were replaced with glass windows, creating more natural light in the dining area. The upper cornice was crumbling and had to be rebuilt. The glass and steel framed doors were replaced with historically accurate wooden, painted ones. Lighting was installed all around the building, including the parking and patio area in the back.

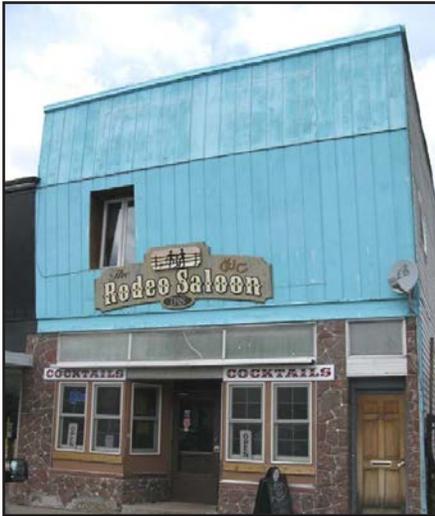
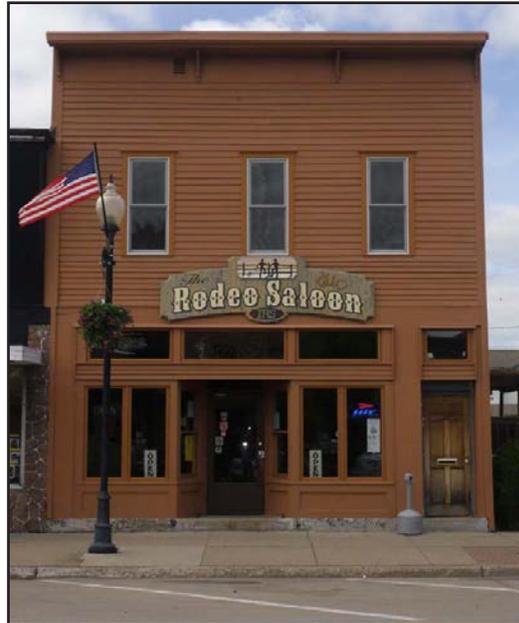
This historical restoration led to increased property value and the business' eventual marketability.

After removing the wood panel faux exterior on the second floor, the owner installed three energy-efficient windows. All the windows and the entry way door were also replaced, and the damaged cedar siding was replaced and repainted.

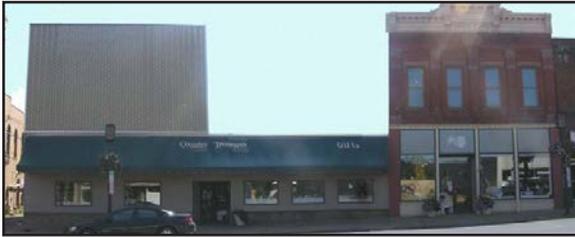
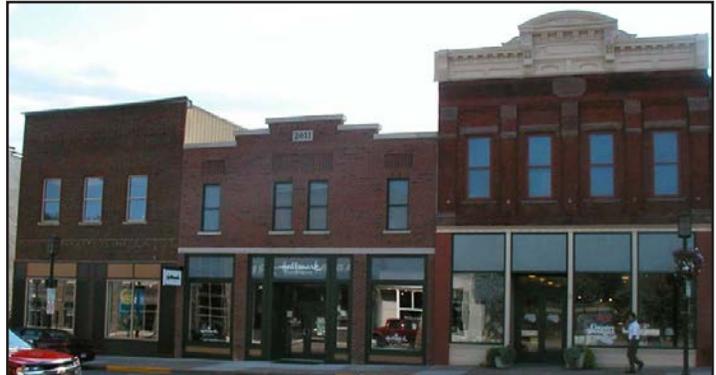
Design creativity enhanced the curb appeal of, and the connections between, the three buildings. This provided the impetus for other projects.

Renovation and construction began on the center and left side buildings in 2011 with the removal of a metal façade that had covered the upper story of the building. The exposed brick was tuck-pointed and three windows with rotting wood frames were replaced. A new false second story brick façade was added to the center building and the entire front of the two buildings was redone with new larger storefront windows and doors. Other improvements included paint, signage, and awning removal.

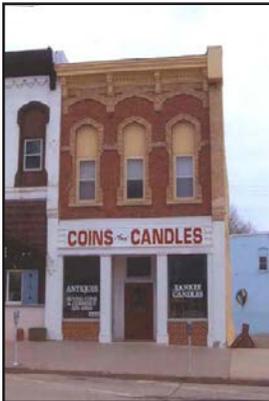
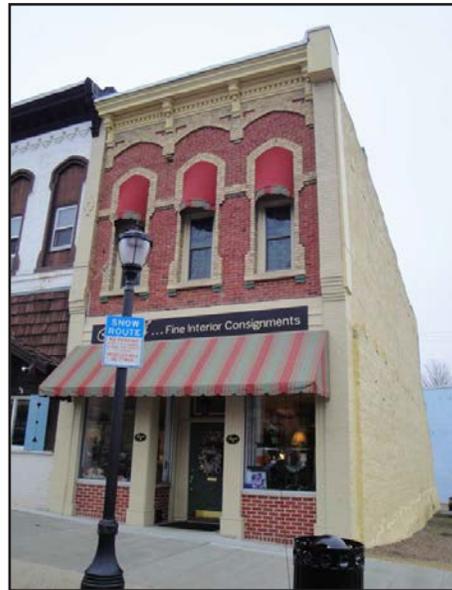
This historic restoration provided an atmosphere well-suited for the owner's consignment shop at minimal cost.

An awning and a custom sign for the consignment shop were added. Upper floor windows were repaired. Custom upper floor awnings were added to complement the lower awning and conceal where the windows didn't completely fill the arches. A new front door, some paint, and outdoor lighting completed the new look.

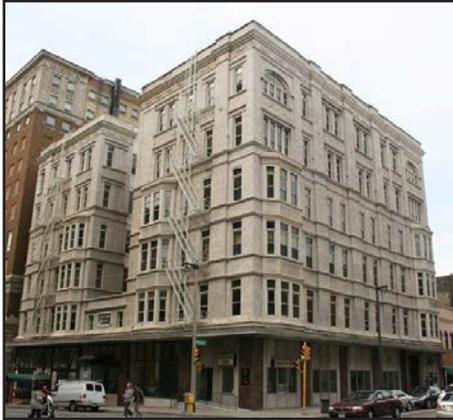
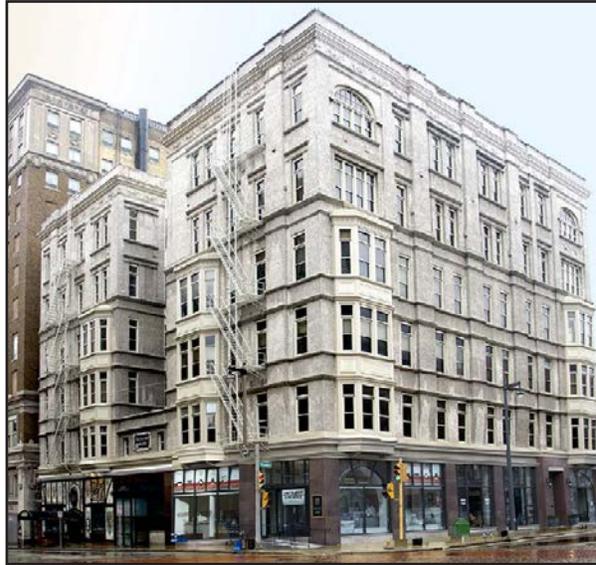
The City of Milwaukee's pop-up store incentive program helped to make the restoration of this historical building possible.

Sustainable design features include the restoration and reuse of existing materials wherever possible, including operable windows, recycled city steam heat, new energy-efficient air-conditioning, and an emphasis on bike commuting tenants, Energy Star lighting, and low VOC paints. The 1960s era stainless steel wrap around canopy was removed. The entire first floor façade was removed and rebuilt with energy-efficient insulation and floor-to-ceiling windows with exposed arches. A handicap accessible ramp was installed and each storefront received its own entrance. Bay windows were also repainted.

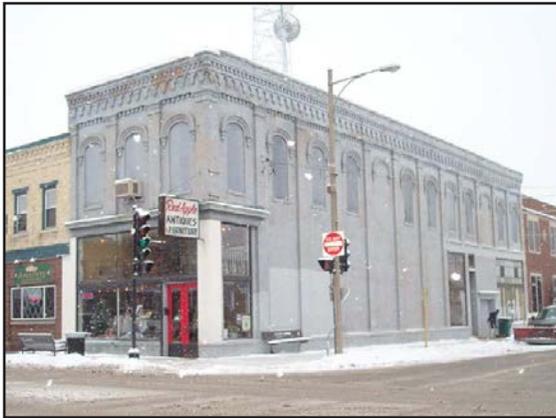
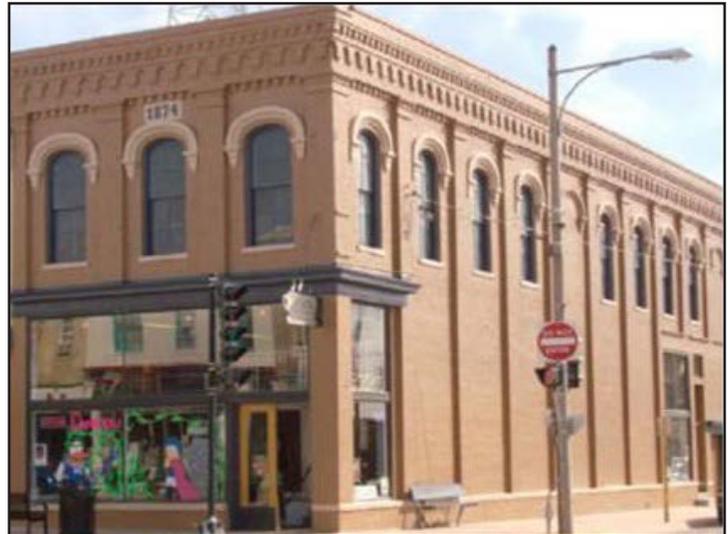
A fresh coat of paint piqued consumer interest and heightened community pride.

When Wes and Julie Crnkovich purchased this 1874 Italianate building in 2009, more than 30 years of neglect meant several repairs needed to be made. The new paint scheme highlights the architectural features of the building. Customers and downtown neighbors say the building is one of the nicest looking buildings on Main Street.

The windows were repaired and re-glazed, the wood trim was restored and reinforced, and, where possible, functionality was restored. Parts of the building required replacement brick, and much of the building was tuck-pointed to prevent water damage. The parapet was sealed, waterproofed, and coated with protective metal paint. Then the entire building was repainted. In a later phase, the plywood was removed from the upper windows, restoring the functionality of the second level.

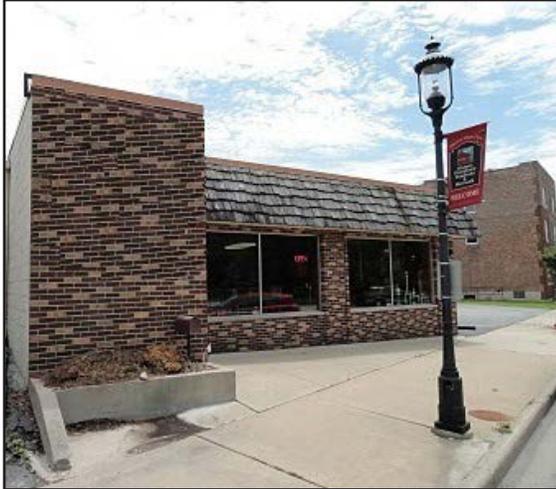
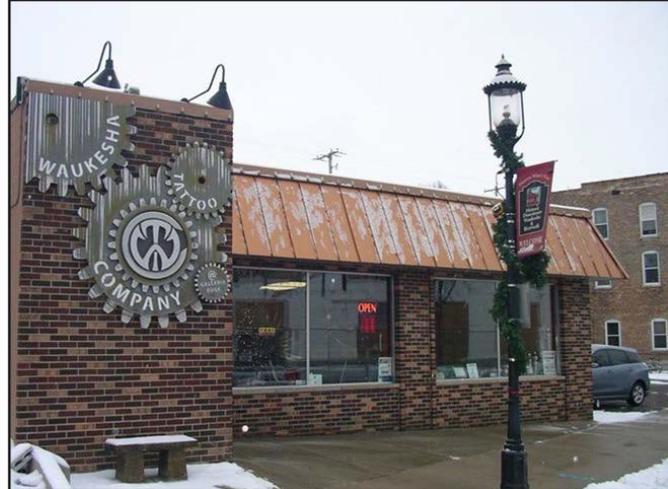
A façade improvement and signage provided a catalyst for other improvements in the neighborhood.

The 1960s-era building was tuck-pointed. The masonry blocks on either side of the building were painted with a rubber membrane paint that would conceal any future cracks. The cedar shingle awning was replaced with a metal awning. New exterior lighting was added to illuminate the new sign. Other improvements included repairs of the roof and down spouts.

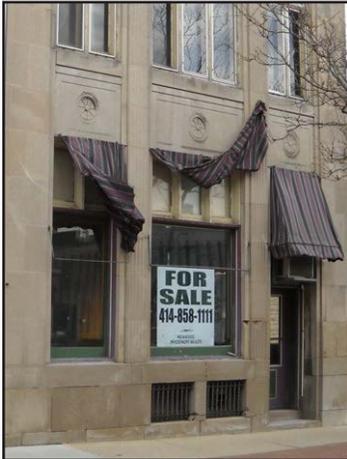
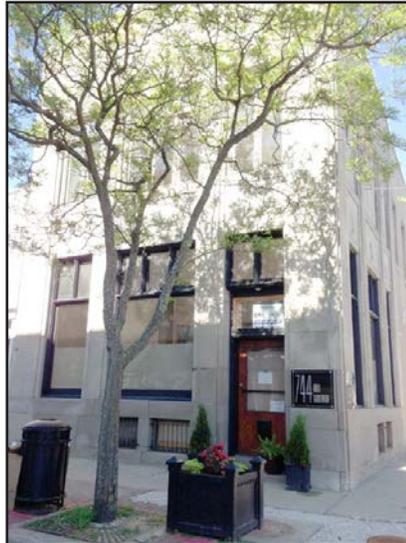
Storefront improvements created an attractive live/work space downtown.

Tattered awnings, blowing freely in the wind, were removed to highlight the building's features of large windows and ornamentation. The front door was replaced and a new sign was designed for the agency.

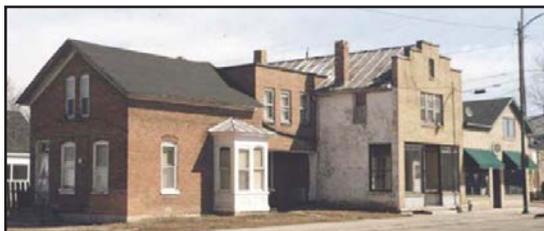
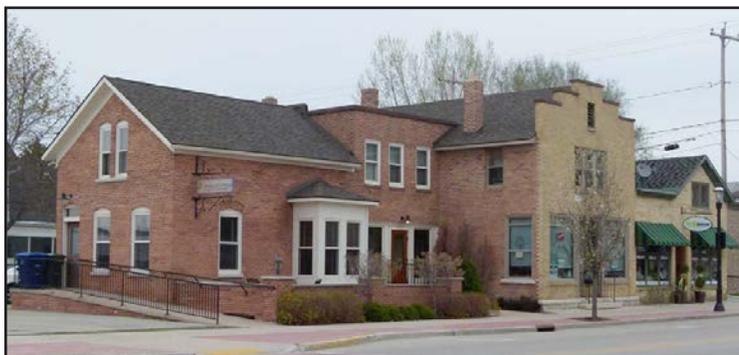
The Main Street Façade Improvement Program helped the owner save run-down vacant buildings from demolition by converting them into income-producing, occupied buildings.

Extensive tuck-pointing needed to be done after the paint was removed and some bricks were replaced. New windows and crown molding were installed around the exterior of the building. Metal columns (not shown) were also restored. A new accessible entry way was built with a new door. Extensive interior renovations included converting residential units into commercial units.

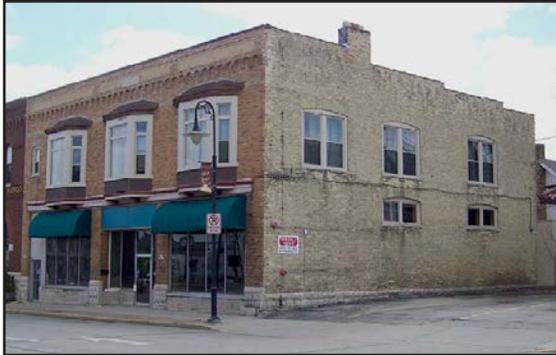
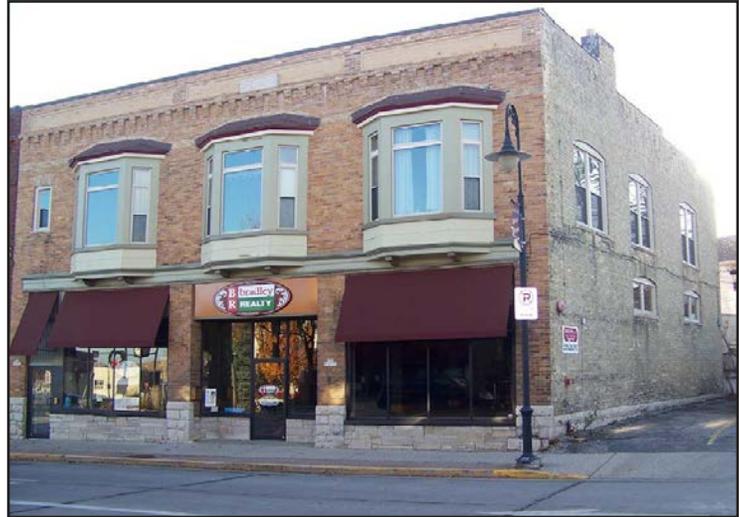
A 50/50 match program provided the necessary funds for needed repairs and led to increased rents and more first-time customers.

There was some minor tuck-pointing, an aluminum soffit was replaced with a bead board soffit, four windows and two doors were replaced with energy-efficient windows and doors, and the frame and canvas canopy was replaced. In addition, paint was applied and a new sign was added.

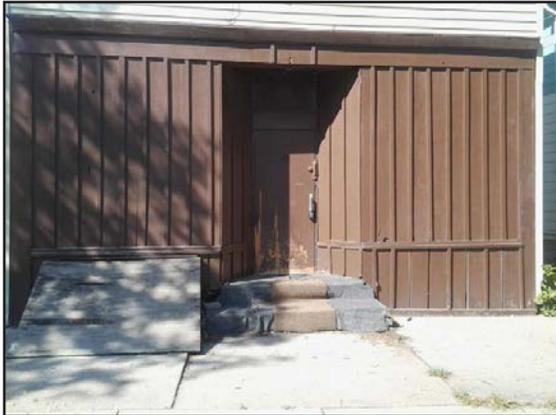
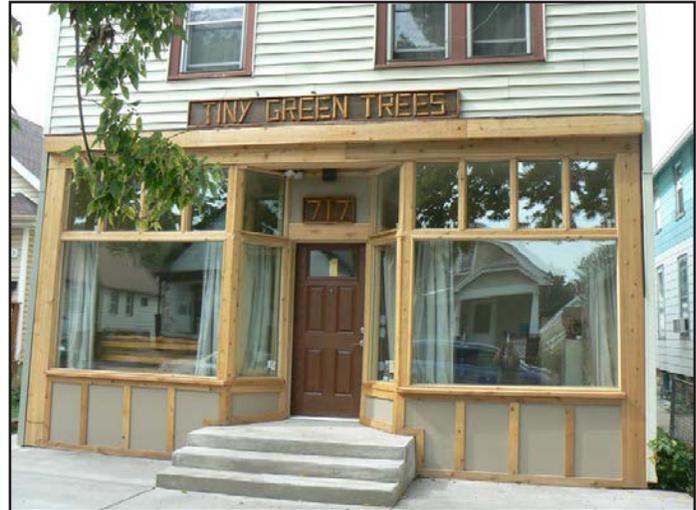
A vacant and blighted tavern was converted into a safe place for children to be cared for and to engage in their environment.

Jeremy and Kelly Belot found a dilapidated tavern near their home and the new Menomonee Valley branch of the Urban Ecology Center. Infusing it with a new vision, the building was converted into an eco-friendly childcare center focused on a healthy, sustainable lifestyle on the main floor, and a residential unit on the second floor. The backyard became a natural playscape, and the interior received a full renovation.

The owners did a full renovation of the property, including extensive landscaping and a roof replacement. The building was partially re-sided, cedar wood trim was added, doors and windows were replaced, and a custom sign emphasizing the nature-based focus of the childcare center was added.
